THE ROTHERY REPORT (TAY BRIDGE INQUIRY)

TAY BRIDGE INQUIRY.

REPORT OF MR. ROTHERY.

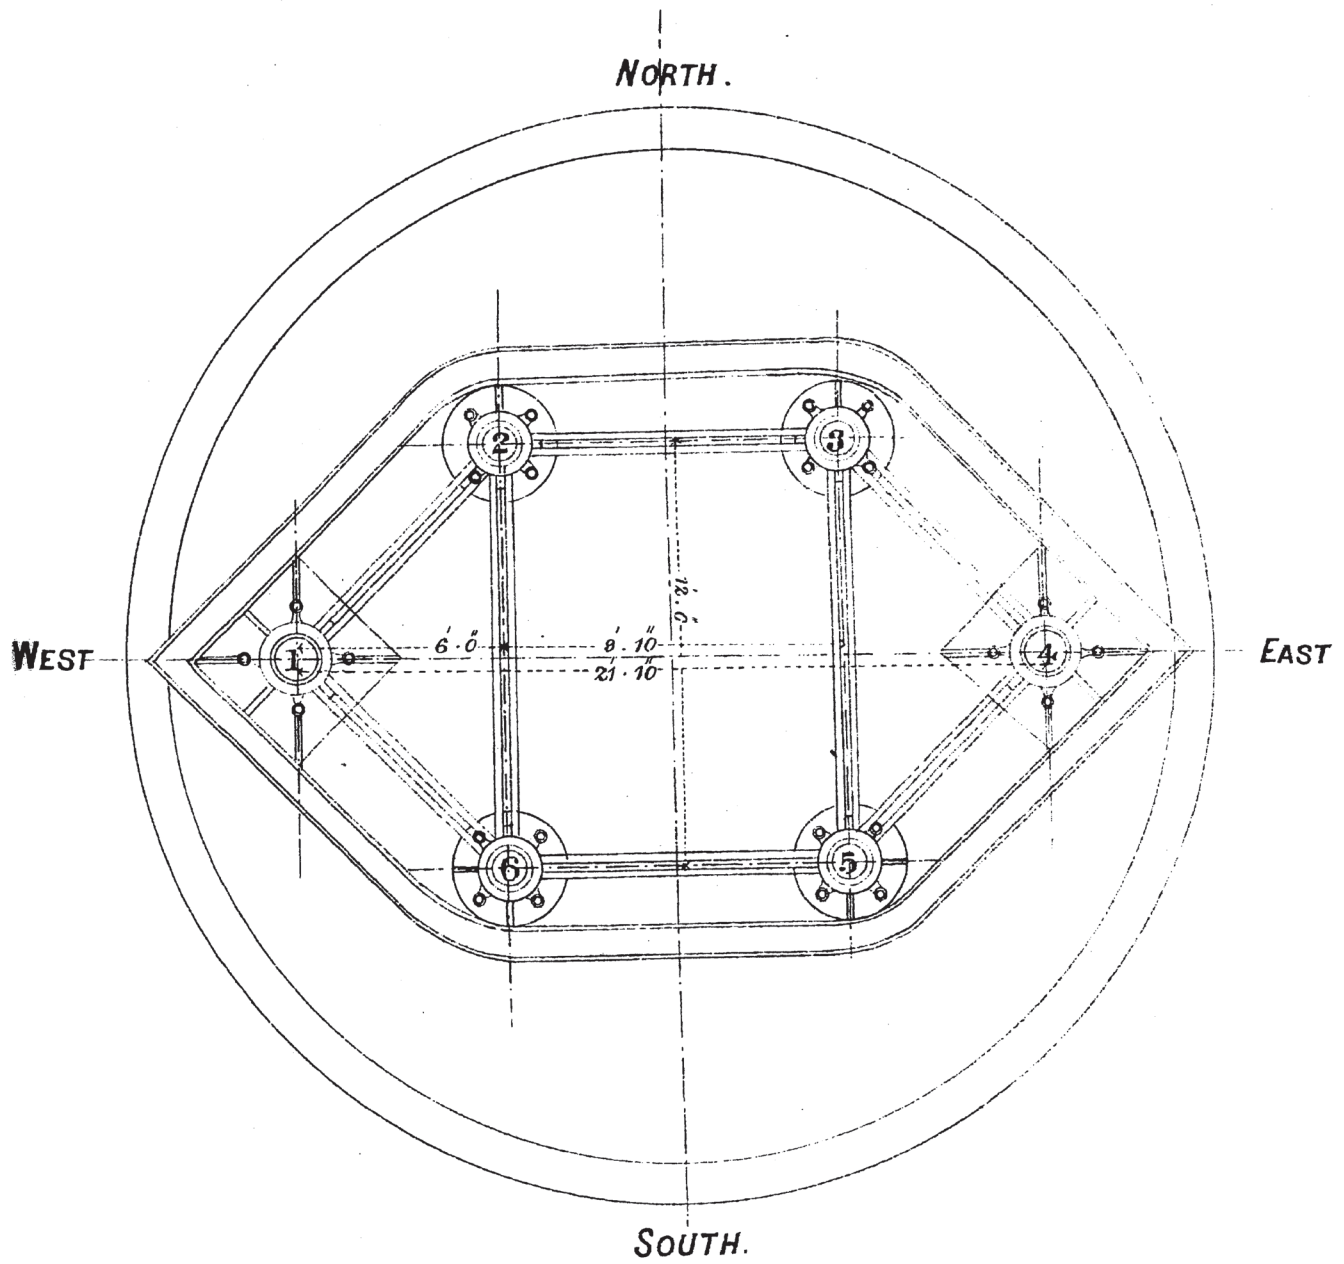
SECTIONAL PLAN OF THE BASE OF ONE OF THE FALLEN PIERS

(26.) We have said that it was originally intended to build the piers, which supported this part of the structure, of brick; but that, when it was found that the rock had disappeared, it was determined to lighten the piers by making them of cast-iron columns, and at the same time to increase considerably the area of the foundations. To obtain foundations for the piers, wrought-iron caissons 31 feet in diameter were constructed on the shore, which, on being lined with 18 inches of brickwork were floated out, and sunk in their proper places. This was an extremely difficult operation, but appears to have been successfully performed. After a caisson had been sunk as low as was deemed necessary, the centre was filled up with concrete; and upon this was built a hexagonal-shaped pier, measuring 27 feet 6 inches from east to west, and 15 feet 6 inches from north to south; the lower part of which was faced with brick, whilst the four upper courses were faced with stone, the centre, as in the case of the caissons, being filled with concrete. And at the angles of the hexagonal pier were placed six cast-iron base pieces, 2 feet in height, and secured to the pier by holding-down bolts passing through the two upper courses of stone; and upon these were raised the columns. The arrangement of the foundations, the pier, and the base pieces will be best seen from the plan annexed to this Report, which is taken from a drawing in Mr. Law's report. *The foundations.*
