THE LAW REPORT (TAY BRIDGE INQUIRY)

TAY BRIDGE INQUIRY.

HENRY LAW, M_{EMB.} INST. C.E.

Dated 9th April, 1880.

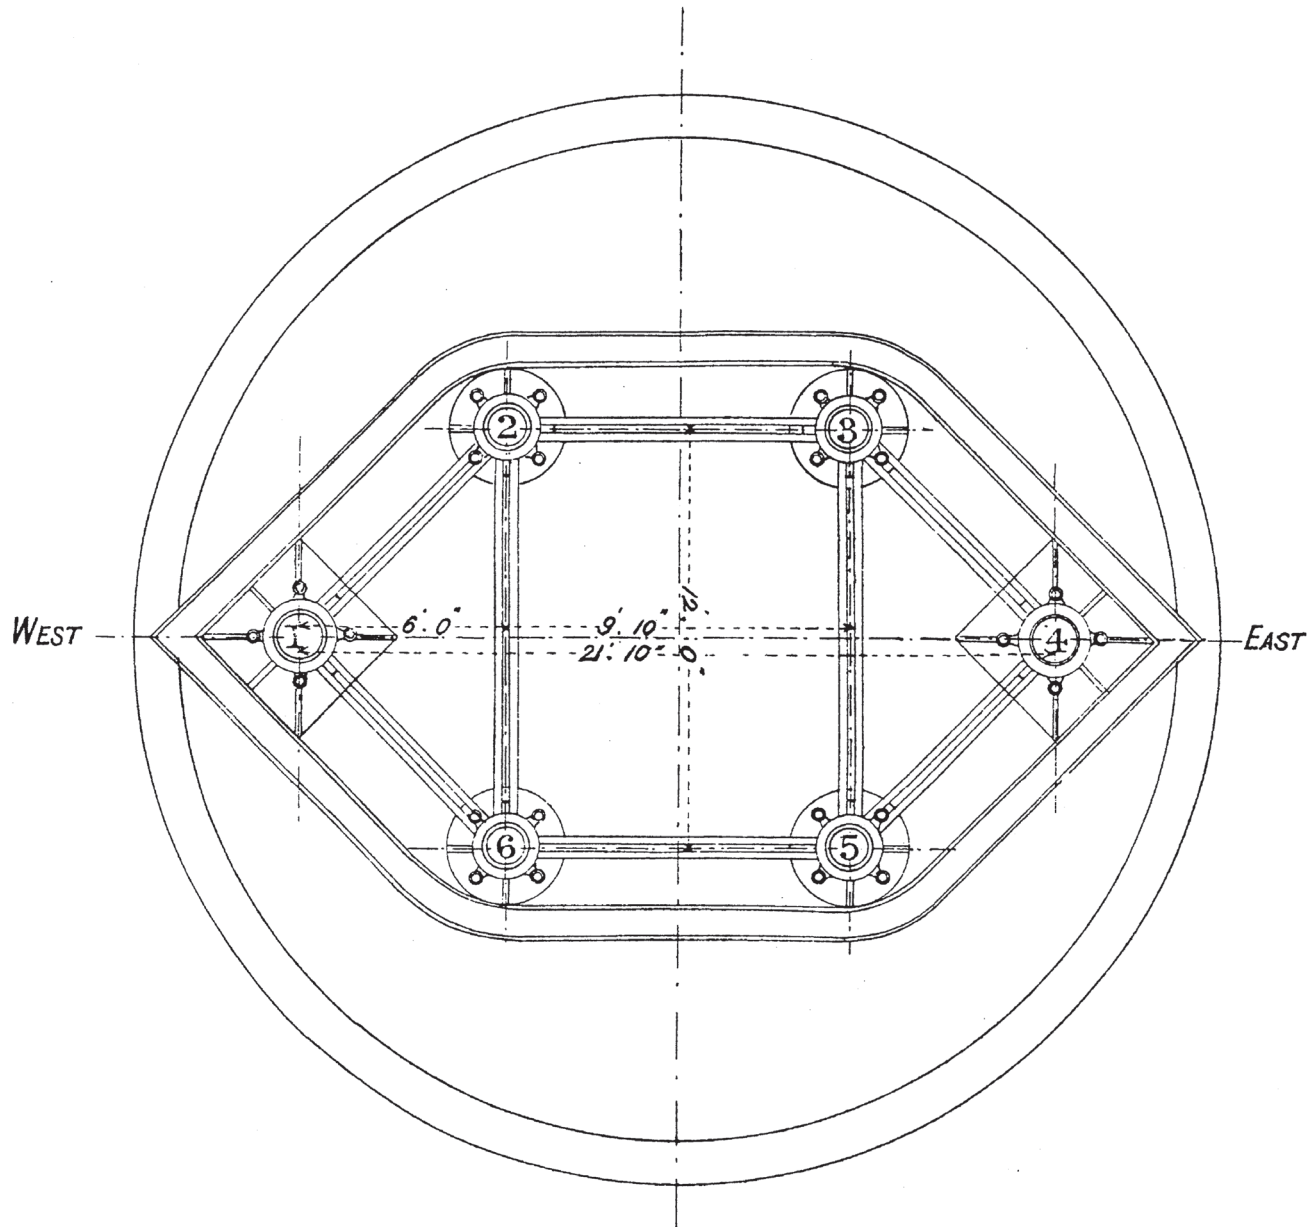
*Drawing N° 1.****TAY BRIDGE.****Sectional Plan of the base of one of the fallen piers.*

The six columns were arranged in the form shown upon the plan, Drawing No. 1, so as to form two clusters, each triangular on plan, and having no other connection at their upper extremities beyond the struts and

ties. The two extreme columns marked 1 and 4 on the plan were each 18 inches in diameter, and inclined inwards at the top 12 inches in their whole height; the other four columns, 2, 6 and 3, 5, were each 15 inches in diameter. They stood in vertical planes parallel to the direction of the bridge, but in those planes 2 and 6 and 3 and 5 were each inclined 12 inches towards each other in their whole height.

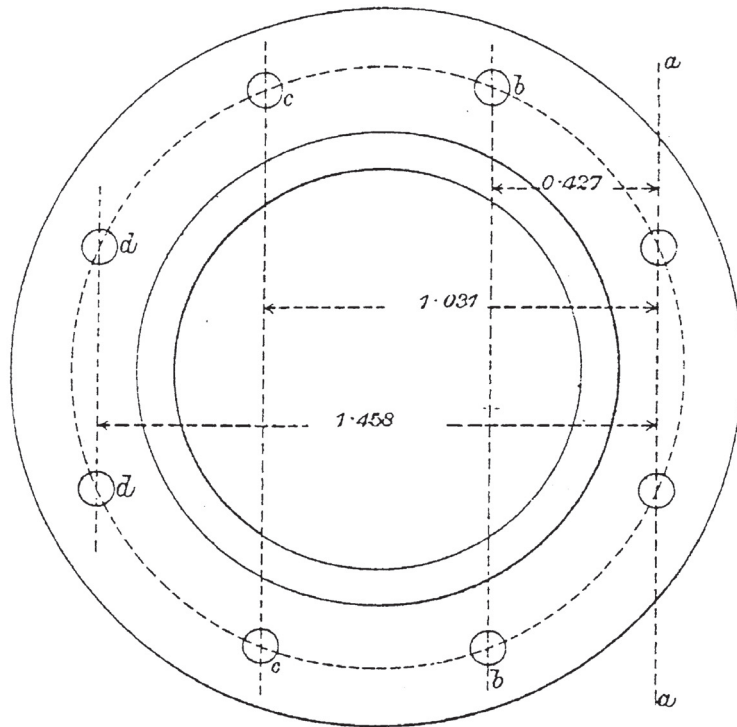
PLAN SHOWING POSITIONS OF BOLTS THROUGH FLANGES OF
15 INCH COLUMNS.

I consider that the mode of connecting the columns at the flange joints was also in some respects defective, the bolts being an-eighth of an inch less in diameter than the hole, and the flanges being separated in some cases as much as $\frac{3}{4}$ of an inch, the bolts could not act as steady-pins, and as in several cases there was no spigot on either of the pipes, there was nothing but the pinching of the bolts to prevent the columns from shifting, and there are evidences that some of them did so shift at the time of the catastrophe.

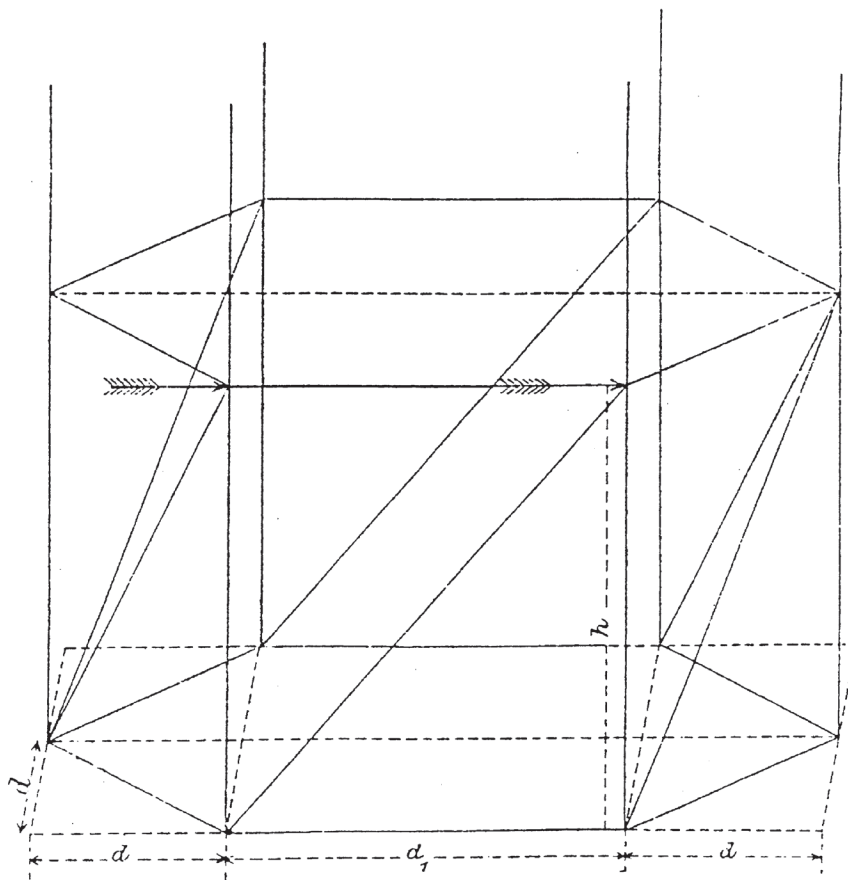
SKELETON DIAGRAM SHOWING THE STRAINS ON THE TIE BARS.

It is also necessary to point out that owing to the double angle which the ties by which the 18 inch columns are braced make, with the direction of the force tending to overthrow the structure, the efficiency of these ties is reduced in the proportion of 1 to 2.73, or to little more than one-third of their full strength, and that any elongation or movement of the ties would allow of nearly three times that movement in a horizontal direction in the point of the column to which they were attached.

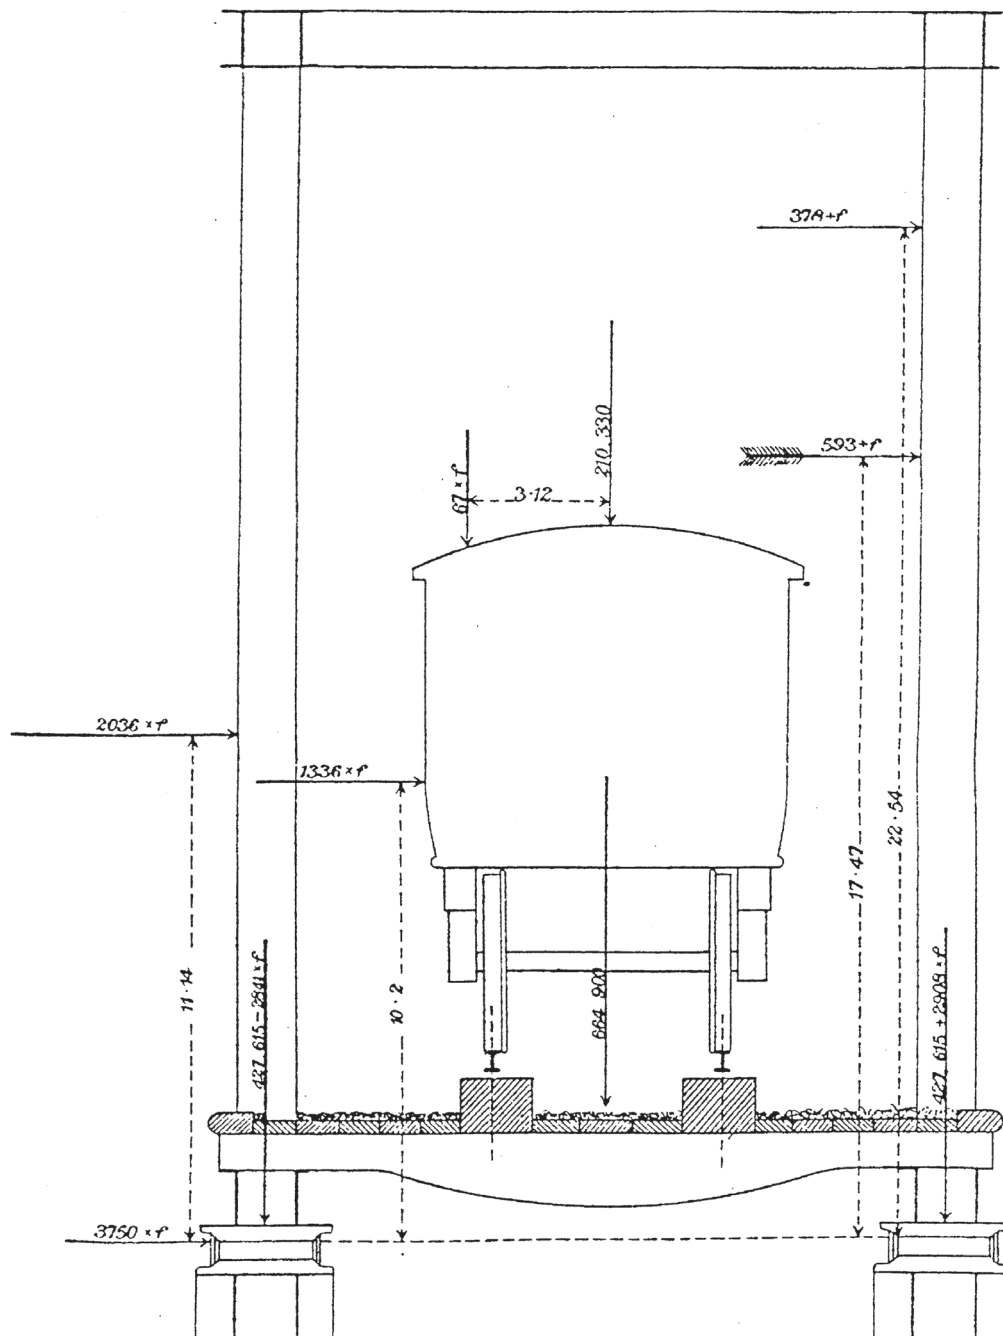
DRAWING No. 5.

The next subject that I have investigated is the effect which the wind would have in lessening the weight of the superstructure upon the windward rollers, and in increasing the same upon the leeward ones, and the results are shown in the following table:—

The slight increase which will be observed in the total pressure upon both rollers with an increased wind is owing to the vertical pressure resulting from the action of the wind on the curved roofs of the carriages.

TRANSVERSE SECTION OF THE SUPERSTRUCTURE SHOWING THE PRESSURES PRODUCED BY
THE ACTION OF THE WIND COMBINED WITH THE WEIGHT OF THE STRUCTURE AND TRAIN.
