Degradation of an Acetal Plumbing Fitting by Chlorine

PR Lewis, PhD, Ceng, FIM, MAF
Dept of Materials Engineering
Faculty of Technology,
The Open University,
Walton Hall,
MILTON KEYNES MK7 6AA,
ENGLAND.

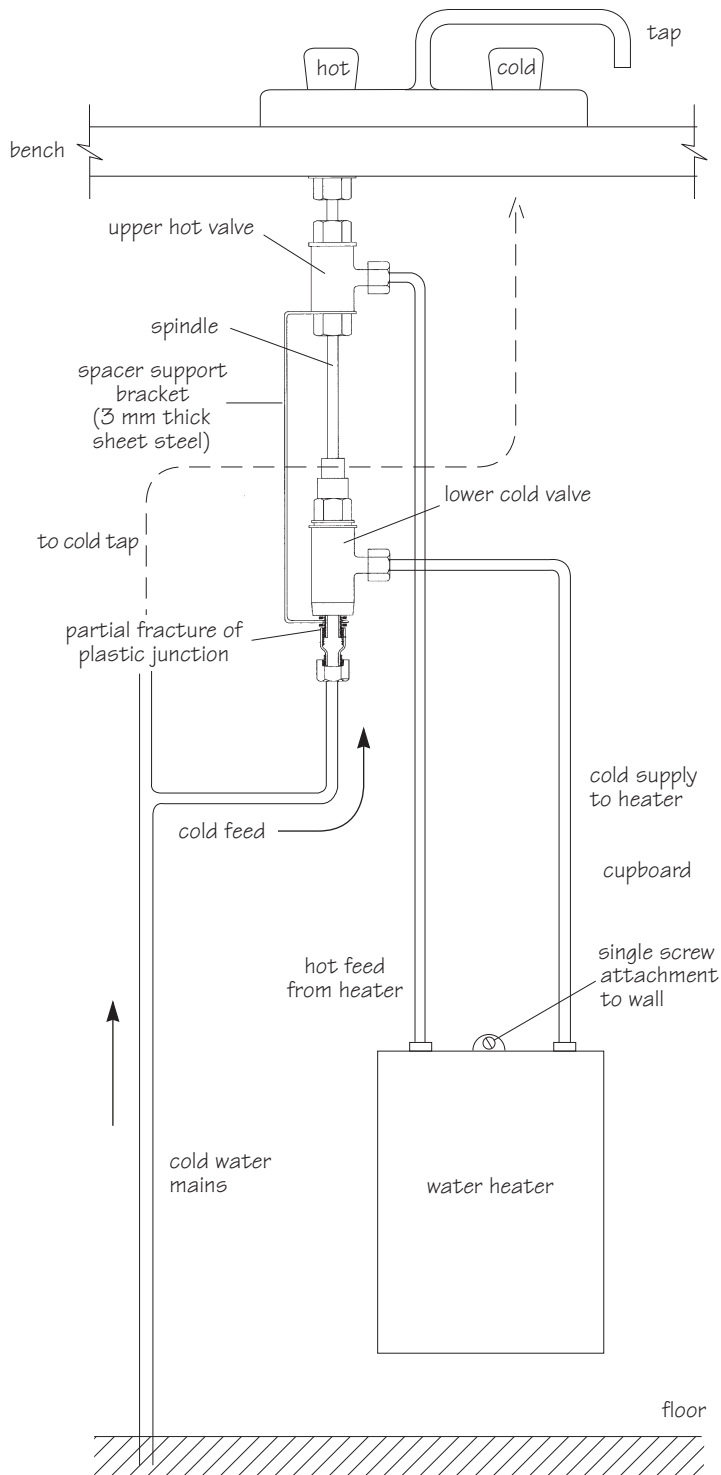
Figure 1

The Failed Sample: When collected, it was clear that the fracture was very old, because the fracture surface was encrusted with brown salts, as shown in **Plate 2**. They turned out, on analysis, to be identical with the local hard water deposits (also present in a nearby electric kettle), a fact confirmed by the water supply company. The failure had thus progressed slowly with time, and there had been slow leakage of water for many months, if not years. The washer and joint showed that it had not suffered any excessive stresses, so the joint could not have been over-tightened by the plumber or anyone else. The joint had also been wrapped with PTFE tape to prevent seepage of water through the thread. The water heater was loose when examined, but was unlikely to have put excessive loads onto the joint since they would have been taken by a steel bracket in the system (**Figure 1**). The cause of failure could thus not be explained by over-tightening or other abuse.

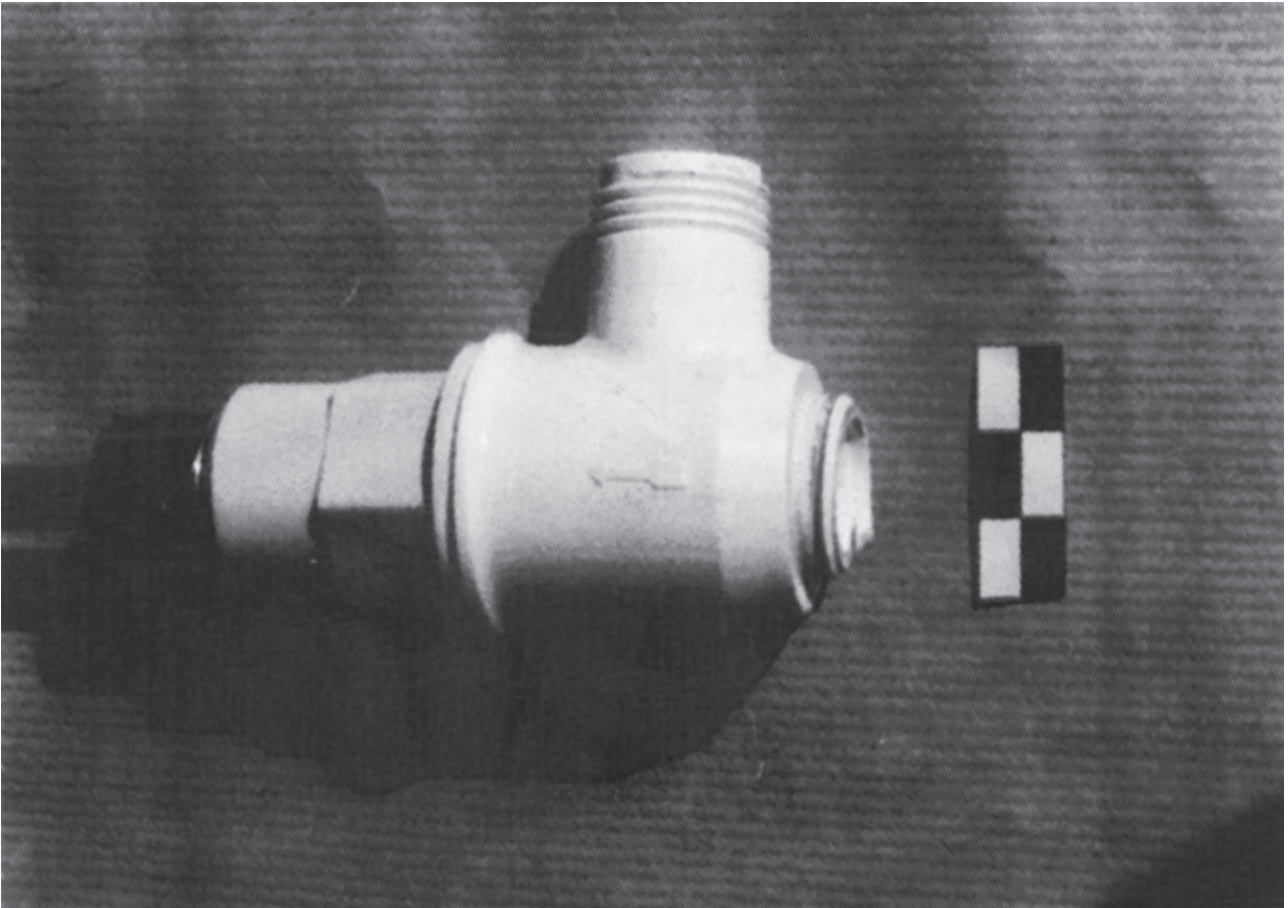
Plate 1

The junction was still in one piece by the time it came for more detailed study. However, it rolled off his desk top onto the floor, and finally broke into two pieces across the thread. The larger fragment is shown in **Plate 1**. However, the insurers refused to accept the possible cause suggested, which implied that the plumbers had wrongly fitted the junction. The problem moved on to issuing of court proceedings, when the University sued the plumbing company and others involved in the renovation of the facilities (Loughborough University-v. Wm Moss *et al.*).

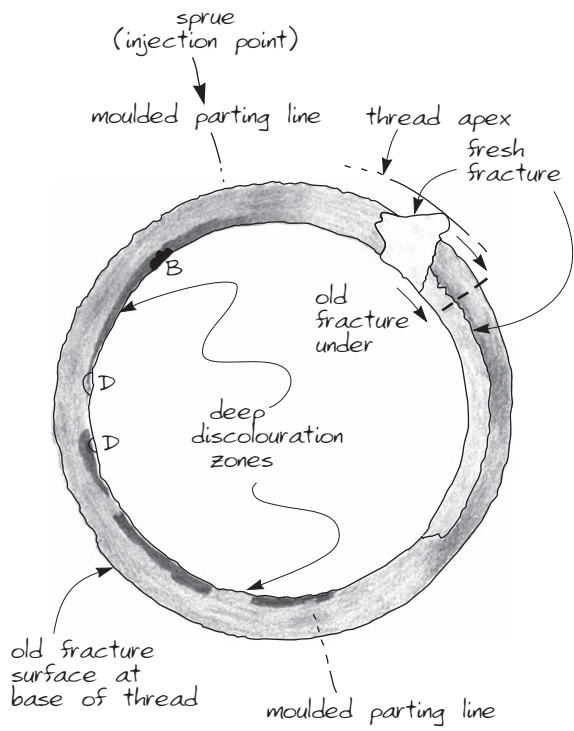
Figure 2

Examination of the fracture surface showed several zones of discolouration (**Figure 2**), as well as the new fracture (clearly distinguished by an absence of later deposits). Injection moulding features such as the injection direction and mould parting line (MPL) appeared to show no obvious correlation with the fracture. However, careful inspection at right angles to the fracture showed several crack branches at the edge at the thread root (**Plate 3**). When continued around the edge, it allowed several crack paths to be identified, as shown by the bold arrows in **Figure 3**. There were about five such independent cracks in all. Examination in the optical microscope also showed the presence of many small weld lines on both outer and inner surfaces, and especially at the root of the thread adjacent to the main crack paths. Some were stained deeply by the salts from the water, showing them to be long standing defects.

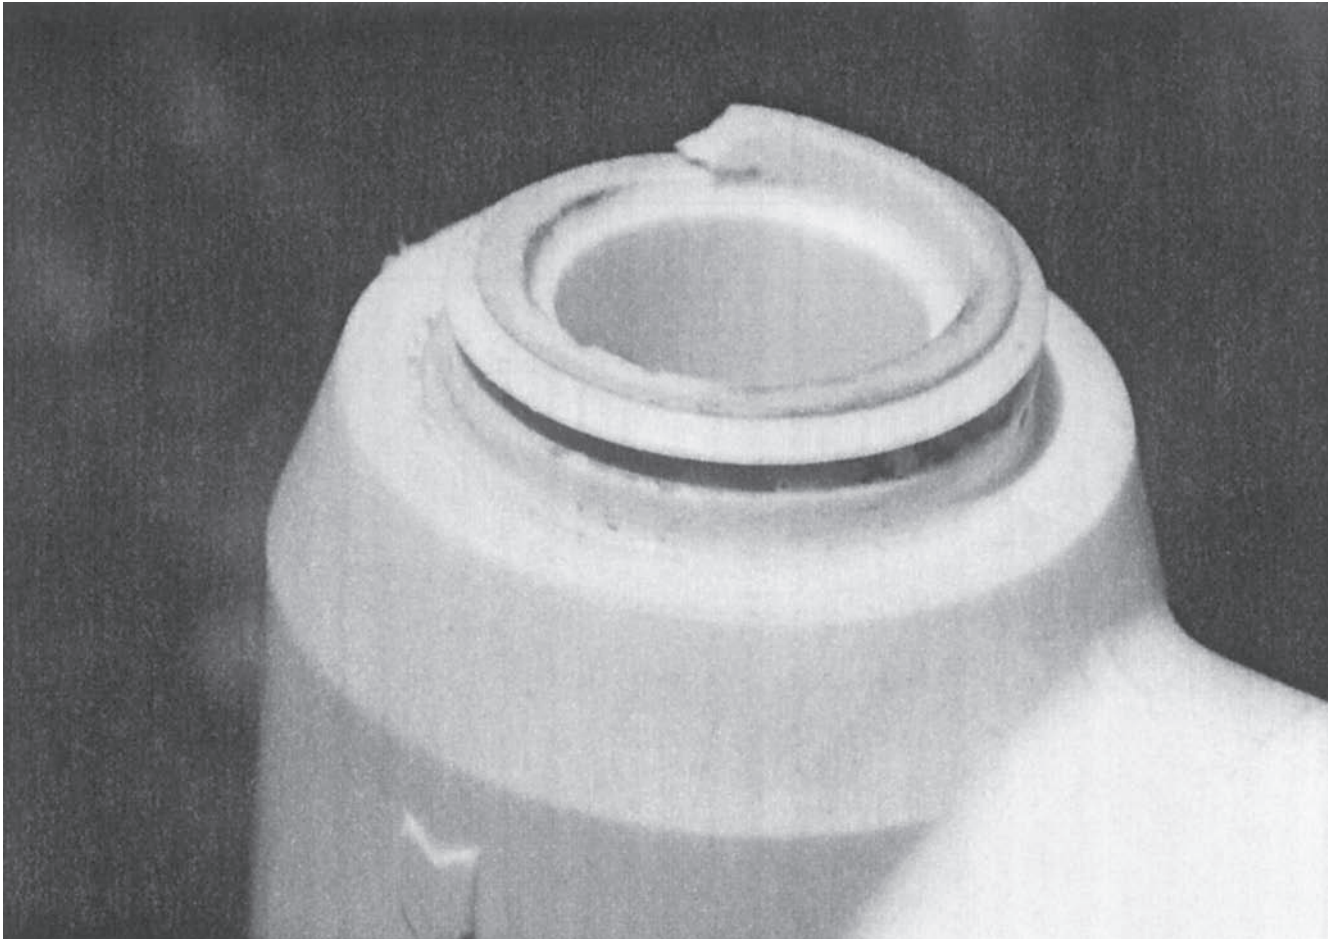
Figure 4

The samples showed many flow lines, which were exposed by dusting the outer surfaces with fine graphite powder (e.g., **Figure 4**). The four different impressions gave different patterns, which could not be correlated with the pattern from the failed moulding. Moreover, the new mouldings did not possess the very serious and deep weld lines of the failed sample. It was concluded that moulding conditions were probably different for the failed sample. It was also noted that the design had been changed: the original failed moulding showed several different section thicknesses, for example.
