Input 6 Stephenson's failed Dee bridge

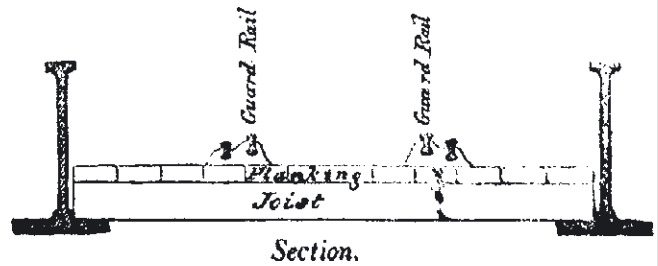
Figure C10 Broken south beam from Dee bridge

Less than a year later, on 24 May 1847, disaster struck. A passenger train had almost crossed the structure when the final span suddenly collapsed. The driver felt it give way under the locomotive, and increasing speed, just reached solid land at the far side of the bridge. Unfortunately, the tender and train did not make it, and fell about 30 feet to the river below. Five people were killed and many injured. Independent investigation by the railway inspectors showed the outer beam had fractured at its centre, on the tension side of the structure (Figure C9).

The design of the beam had been used in smaller spans in previous bridges without failure, so what caused failure on the Dee? The beam had an I shape in cross-section and was bolted together from three beams. It was reinforced with longitudinal wrought iron straps, which were attached at either end to the cast-iron beam. However, the beam was not strong in tension and fractured in a brittle way near the centre of the span.

The rails were fixed to planks laid on oak joists, which sat on the lower flanges of the cast-iron beam (Figure C10). As a precaution against fire, 18 tons of ballast had been deposited over the planks just before the accident.

Lateral movement was supposed to be restricted by lateral wrought iron tie bars, but Captain Simmons of the Royal Engineers noted that they could move 0.75 inch in their dovetailed sockets. In addition, the failed girders were not exactly straight when cast.

Although fatigue was not appreciated at this period, the investigators hinted that 'repeated use' could have weakened the beam. No hollows were found in the metal, however. The estimated load at failure was much lower than the maximum design load.

All bridges of similar design were strengthened, and the Board of Trade initiated a series of tests to provide more realistic design rules in using cast-iron. Stephenson never used cast-iron again, starting his own experiments on wrought iron, which he used successfully in the hollow tube monocoque structure of the Britannia and Conway bridges. The extra material costs were large, compensated by the greater margin of safety.
