Tay Bridge disaster

Designed and edited by The Open University

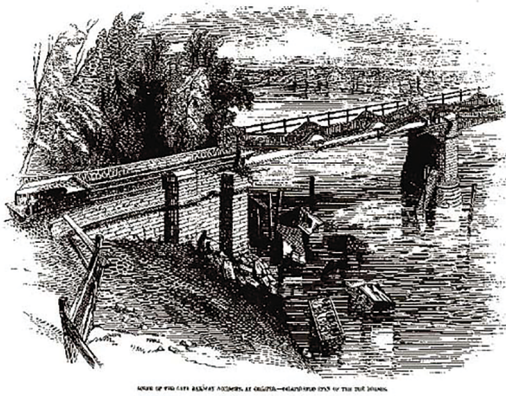
Figure 8 Representation of the damaged Dee bridge, 1847. A cast-iron beam collapsed under a passing passenger train. The locomotive reached the bank at left without damage, but the train fell into the river. Part of the beam is leaning against the pier at right

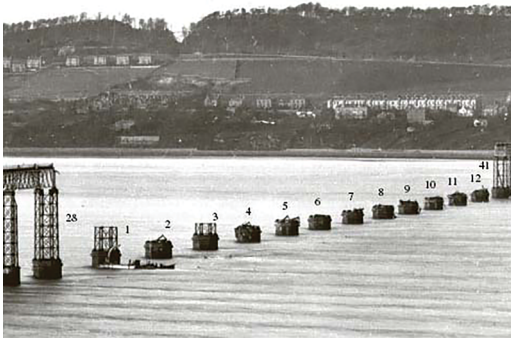
Figure 20 Fallen piers as seen from the south bank of the firth. For the purposes of the BoT investigation, the piers between 28 and 41 were numbered 1–12, as shown in the picture

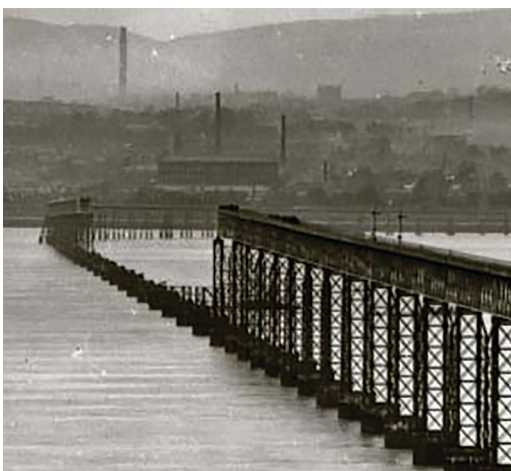
Figure 21 The missing high girders section, looking north, with Dundee in the background. Note the many tall chimneys, which were clearly unaffected by the storm. The photograph also shows the steep downward gradient of the final part of the bridge

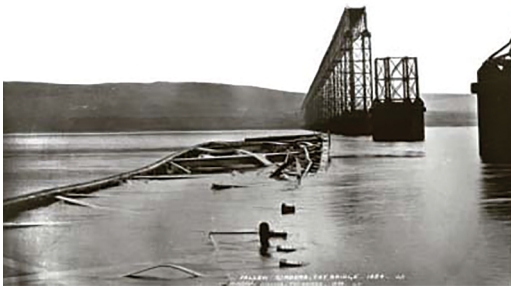
Figure 22 Remains of the high girders lying on the estuary floor, with the south side of the fallen bridge in the background

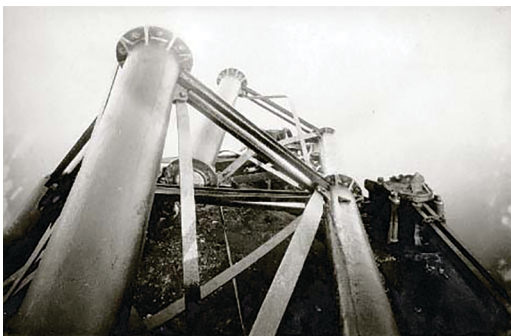
Figures 23 and 24 present the east- and west-facing views of a collapsed pier, pier 5, which lay just ahead of the train before it was lost in the disaster. Figure 23 shows parts of two tiers of what was presumably the lowest part of the cast-iron pier on this platform. The columns point towards the east, indicating the lowest tiers fell in this direction during the collapse.

Figure 23 Collapsed pier 5, looking east, towards the sea

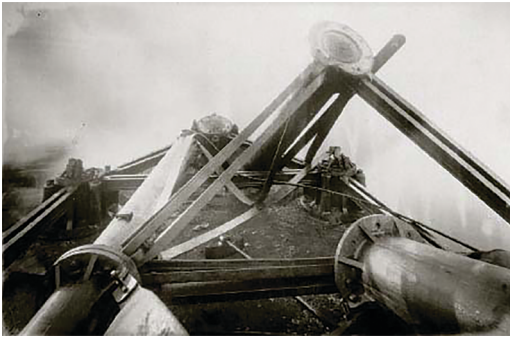
The reverse angle picture, the view looking west (Figure 24), shows the lower columns of this set of tiers, which at the right have broken at a flange. The parts are above one another in the picture. The columns are still held together, however, by their wrought iron struts – the double members that were horizontal in the original upstanding pier. On the other hand, many of the original diagonal single tie bars have broken away, and in some cases, become grossly deformed during the collapse. For example, there is just such a tie bar in the centre of Figure 24, which has been bent double. It indicates the material behaved in a ductile and tough manner during the collapse.

Figure 24 Collapsed pier 5, looking west, looking upriver

There is a prominent round tie rod on the platform itself, one of which has an end connection (lower part in the centre of [Figure 24](#)) still attached. The component was one of the horizontal reinforcing rods, which crossed – either south-west to north-east, or south-east to north-west – from opposite columns in the original pier (see plan view in [Figure 15](#)). The end connection was made from grey cast-iron, and fitted at the column heads, between the lugs for the tie bars and struts ([Figure 16](#)). [Figures 25](#) and [26](#) show similar views of the platform of pier 4 – south of pier 5 – which was the pier over which the train had just passed when the disaster happened.

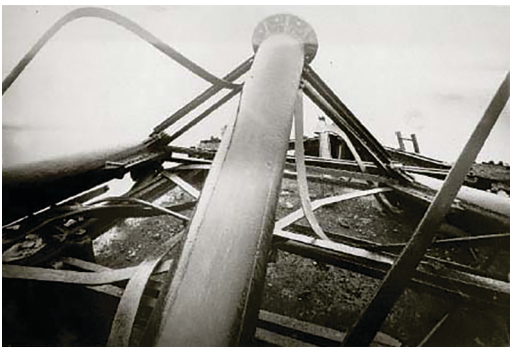
Figure 25 Collapsed pier 4, looking east

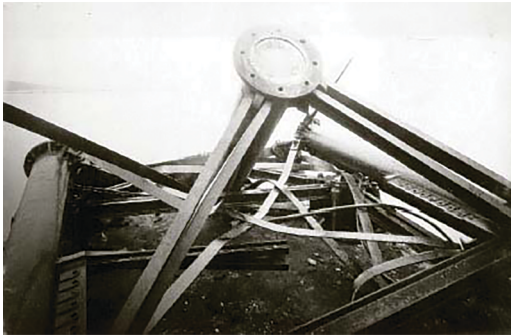
Figure 26 Collapsed pier 4, looking west

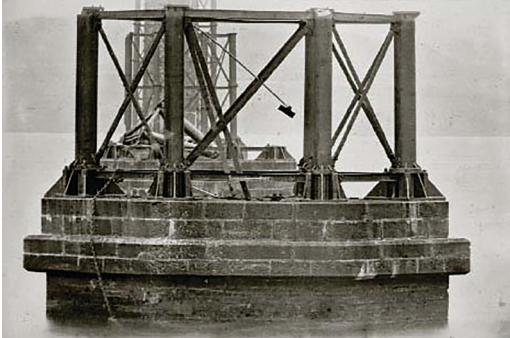
Figure 27 Remains of pier 3 with one tier left standing, viewed from pier 4, looking south

The broken southern lug can also be seen in cross-section in [Figure 27](#), at the base of the third column from the right. The section torn away is a sector of slightly more than 90°, and the remains of the hole at its apex is just visible. A high magnification of the column base is shown in Figure 30, below, with the lug arrowed. Another broken tie bar appears to be lying on the stone platform.

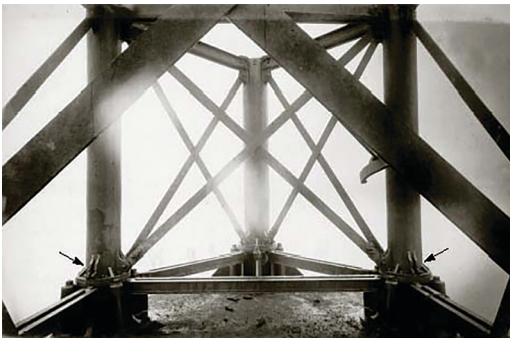
Figure 28 Remains of pier 3, looking west. The broken east-facing lugs are indicated by the arrows

The bases of the columns to which they were attached originally on pier 3 deserve closer inspection. Even at this scale, the two fractured lugs where the tie bars were formerly fixed are clearly visible at the right-hand and left-hand sides of [Figure 28](#) (arrowed). The southern (left-hand) column base in [Figure 28](#) is shown at about $\times 8$ magnification in [Figure 29](#), below, and it is now possible to see the fractures more clearly.

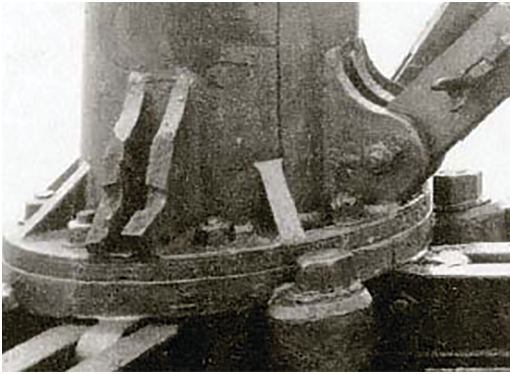
Figure 29 Blow-up of the southern column's lug in Figure 28 showing tapered bolt holes and broken metal surface

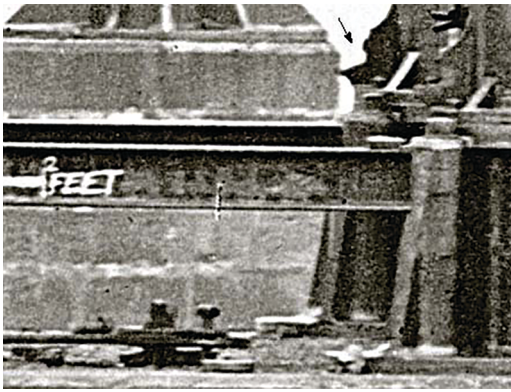
Figure 30 High magnification of part of Figure 27 showing the southern broken lugs (arrowed)

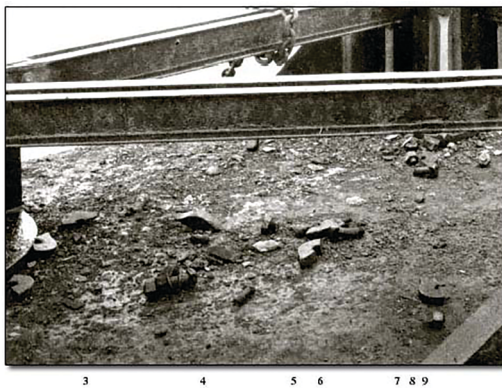
Figure 31 Platform of pier 3 showing nine broken lug ends. Numbers 1 and 2 align horizontally with pieces; the remaining numbers align vertically

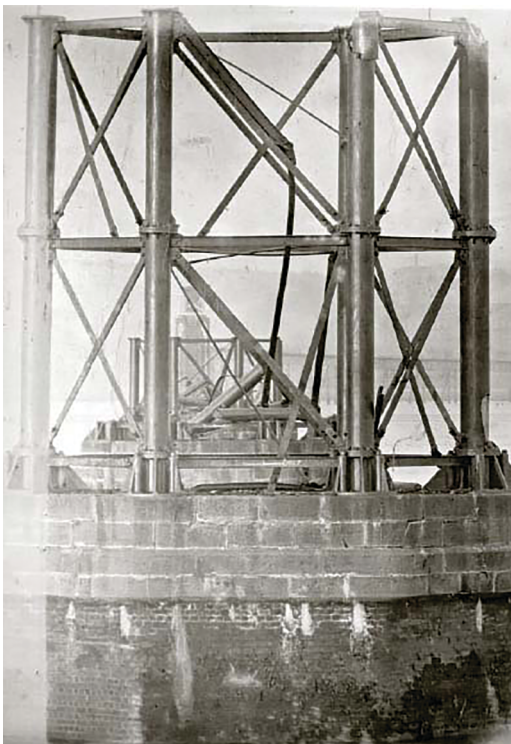
The final example of a partly collapsed pier is pier 1, photographed from the base of pier 28 and shown in [Figure 32](#). Fracture damage to the flange at the top of the second tier is visible on the east-most column (top right); a large chunk of metal has broken off. The southern column (right of centre) exhibits a matching fracture where the parts are still held in position by the wrought iron strut. Propagation of the same crack has also released the top lug, with the tie bar and strut still attached, so they hang in the centre of the pier.

Figure 32 Pier 1, looking north, showing two upstanding tiers of columns and damage to column flanges

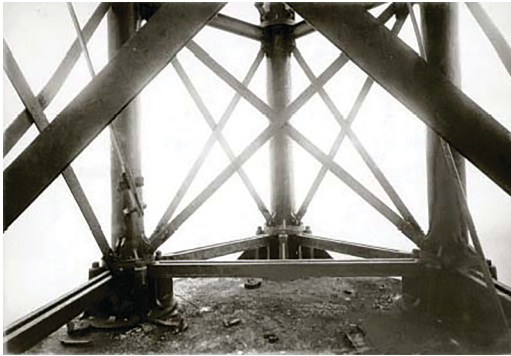
The damage overall is more severe than in the case of pier 3, but it is still possible to identify the pattern of fracture to the principal components. The second picture of pier 1 is shown in [Figure 33](#): a view of the platform looking west towards the western columns. The image has been made lighter and the contrast increased to highlight parts lying on the platform and their fracture surfaces.

Figure 33 Fractured parts of pier 1 on the platform, looking west

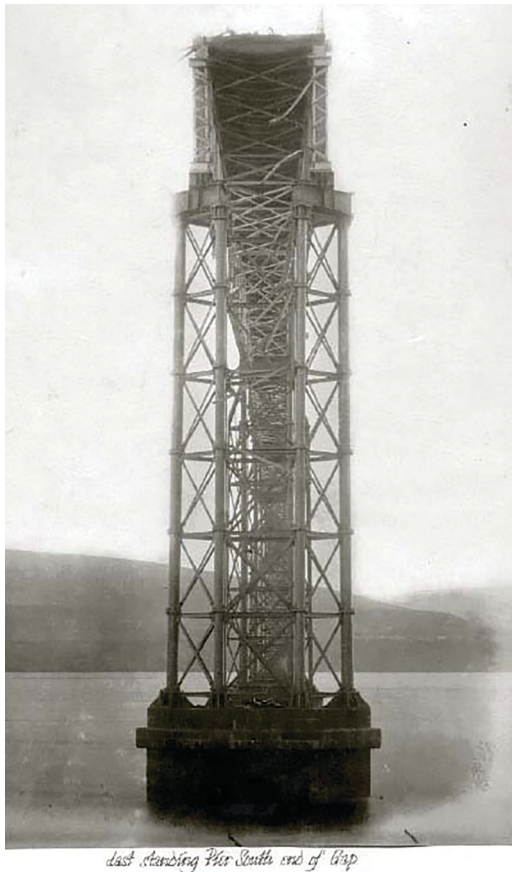
Figure 34 Standing pier 28, looking south, about a week after the disaster

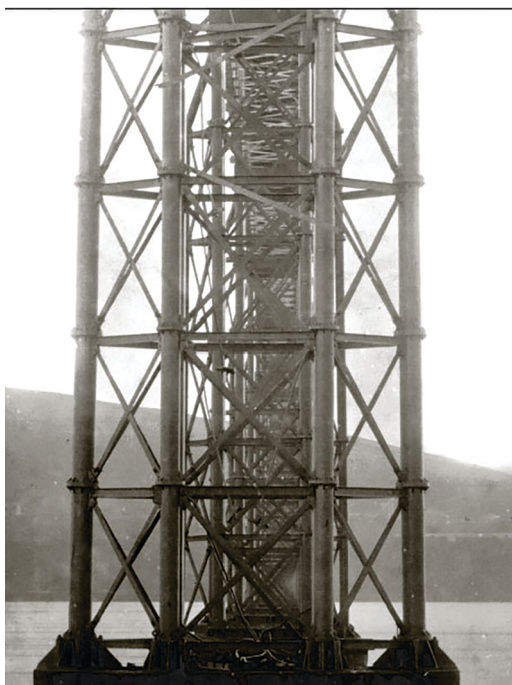
Figure 35 Damaged tie bars and struts of pier 28 and the debris pile on the platform

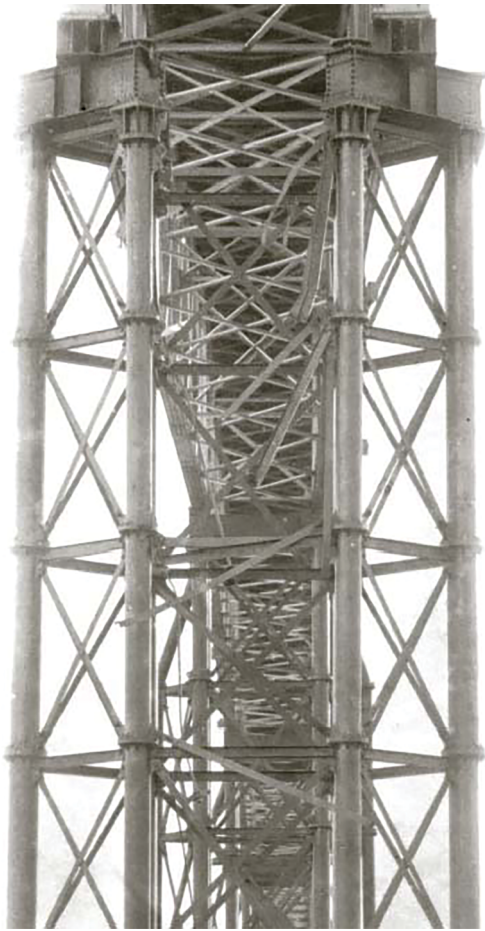
Figure 36 Damage to tie bars and struts of pier 28. In the centre of the top-most tier, a diagonal tie bar has been bent into a U shape. While just below it a strut has been bent after an impact and hangs near the column

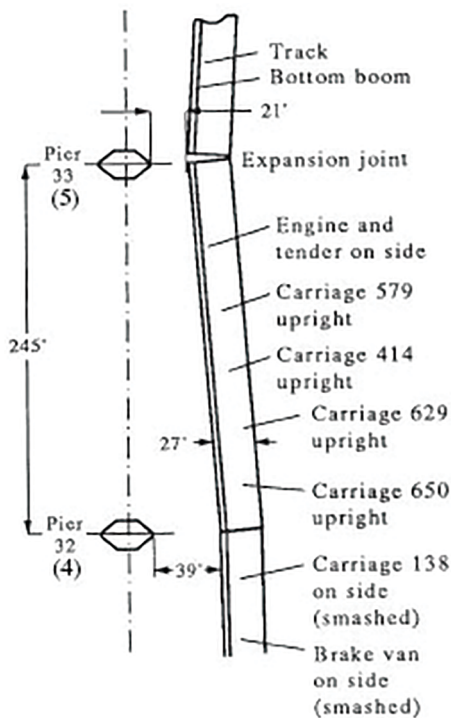
Most of the train was lying inside the fifth span of the high girders, counting from the south side left standing ([Figure 38](#)). The horizontal distance between the girders and the edges of the platforms varied between 16 feet and 51 feet; the fifth span lay between 21 feet and 39 feet from the adjacent platforms. As the piers were 88 feet high, they cannot have simply toppled over, but must have collapsed in a more complex way.

Figure 38 Plan of the fallen high girders in relation to piers 4 and 5 of the collapsed bridge, showing the position of the train and carriages

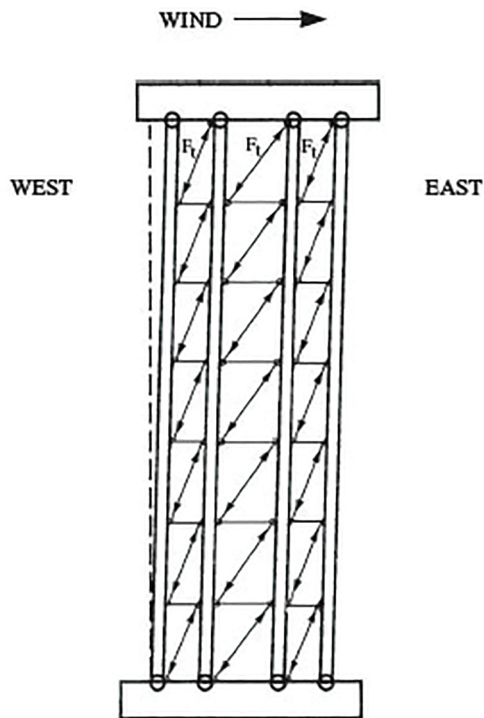
Figure 39 shows a simple model to explain the failure of the piers. The lateral wind loading on the top of the pier bends to shear the pier from a rectangle into a parallelogram. In turn, this stretches the tie bars and also strains the bolted joints at the top and bottom of each column.

Figure 39 Section of a pier showing tie bars stressed by simple tilting of the pier to the east, the lee side
