Input 4 Cast-iron bridge at Ironbridge

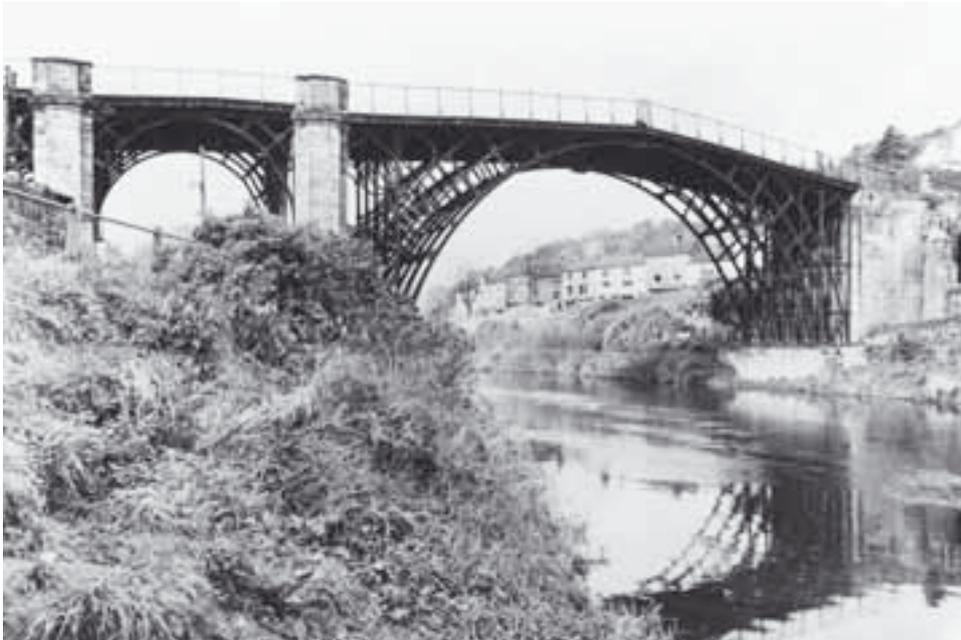
Figure C5 Bridge at Ironbridge, Shropshire, England

The size of castings was increased, culminating in the famous cast-iron bridge crossing the Severn river at what became known as Ironbridge, near Coalbrookdale in Shropshire (**Figure C5**). Built in 1779, it was intended as a pedestrian route for workers, and had ample clearance to allow high-masted sailboats underneath.

Conservation of the Coalbrookdale bridge was needed in the 1970s owing to movement of the masonry abutments, which created brittle cracks in some of the beams. The affected beams were replaced or mended with epoxy resin. The masonry was supported by a counter arch of reinforced concrete and stainless steel built into the riverbed.

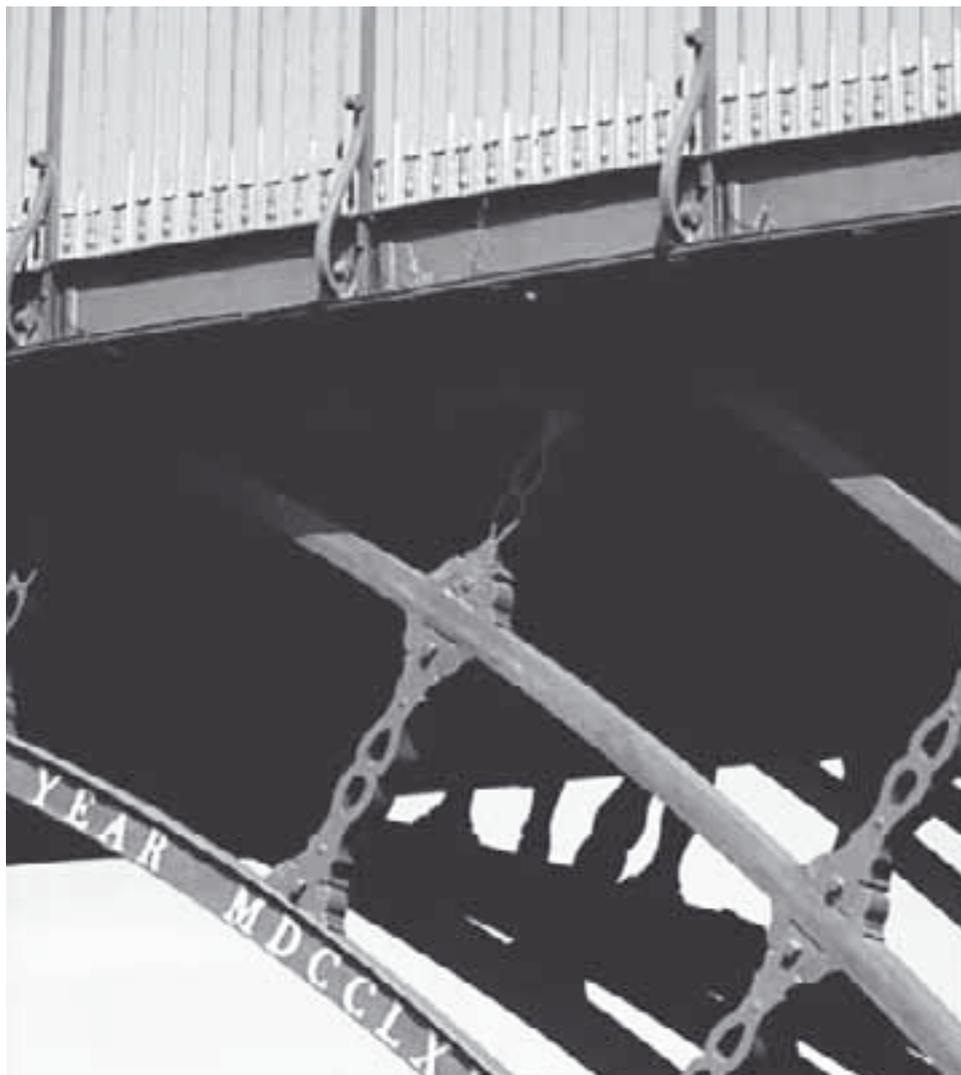
Figure C6 Joints in the bridge at Ironbridge

Owing to the brittle nature of the material in tension, structural members could only be used in compression. The designers of the bridge realized that significant tension or bending stresses could not be allowed, so all of the large cast beams were used as arches, and so were put into compression at all points in the structure. In order to join the large girders, dovetailed joints and wedges were employed, borrowing the idea from carpentry (**Figure C6**).
