THE LAW REPORT (TAY BRIDGE INQUIRY)

TAY BRIDGE INQUIRY.

HENRY LAW, M_{EMB.} INST. C.E.

Dated 9th April, 1880.

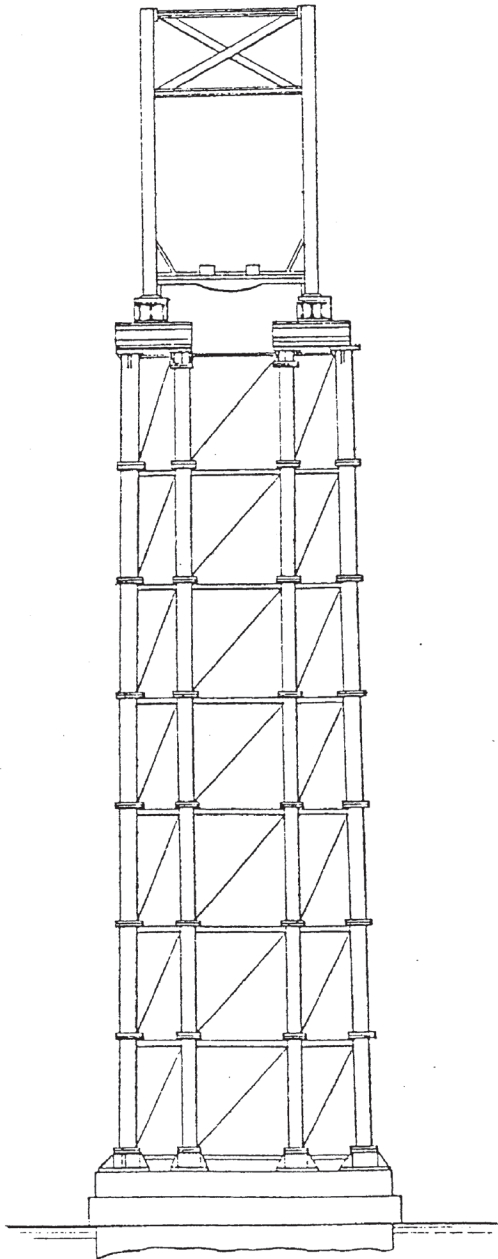
DRAWING No. 5.

From these circumstances it would result that a lateral pressure against the columns would produce movement in the struts and ties, resulting in the latter becoming slack. And this movement actually did take place, in some of the tie bars still standing I found packing pieces of iron a quarter of an inch in thickness had been introduced between the gibs and cotters, and on enquiry I learned that these had been introduced from time to time since the opening of the bridge.

For the slackening of these ties and struts means the removal of that condition upon which alone the power of the structure to resist being overthrown by a lateral pressure depends. And it is easy to conceive that a storm of the violent character of that of the 28th of last December would produce such movements, in the connections of these struts and ties with the columns, as would render the columns unable to sustain the additional weight of the train and the lateral pressure of the wind.

*SIDE ELEVATION OF ONE OF THE PIERS SHOWING ONLY THE BARS
IN TENSION*
