Tay Bridge disaster

Designed and edited by The Open University

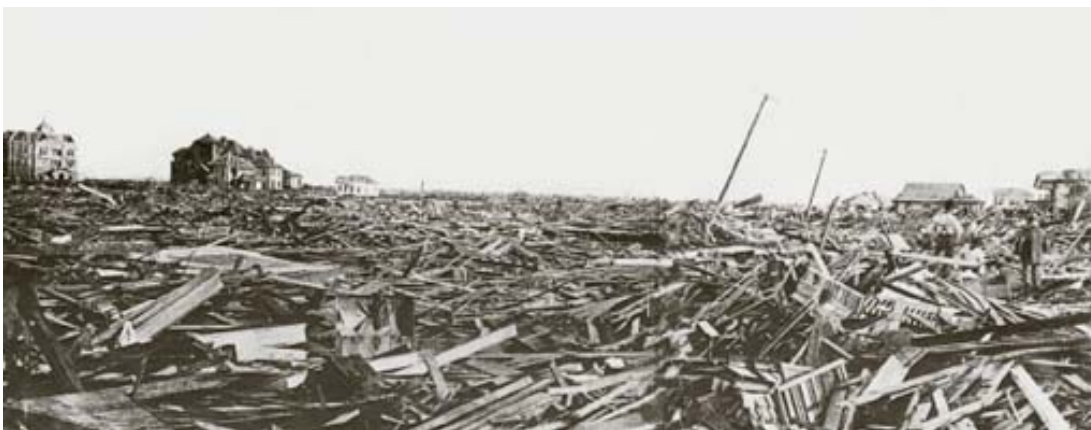
Figure 3 After the hurricane, the wooden houses were devastated, while brick buildings

remain relatively unscathed

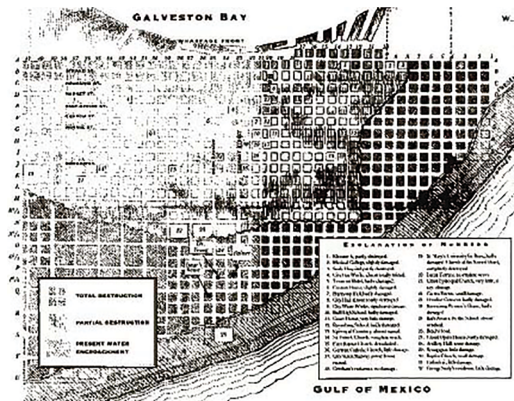
As a direct result of the power of the winds, more than 2600 houses were totally destroyed (Figure 6), with an estimated 10 000 people made homeless. One reason for the high level of destruction was the low-lying position of the port, with most of the city built on an island off the coast.

Figure 6 Map of the city showing the great extent of destruction

Yet the port was reconstructed quickly from the remains of the old, although many protective measures were then incorporated into structures. Many buildings were raised seven feet to give greater height above the sea level, and a sea wall built to limit the effects of any future storms.

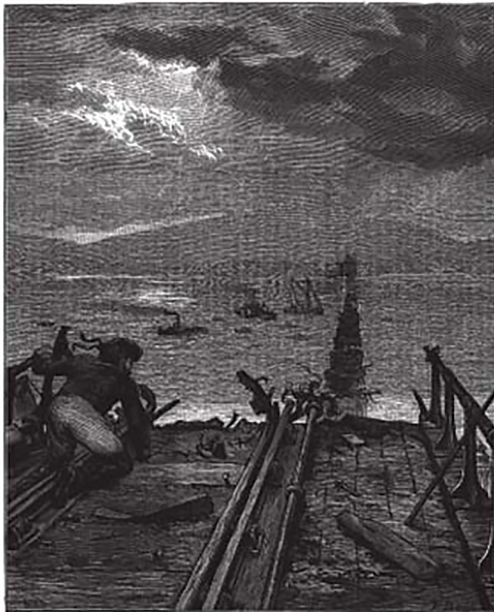
THE TAY BRIDGE DISASTER: VIEW OF THE BRIDGE DEBRIS FROM THE NORTH PIER—END PAGE 17.

Although at times he was forced to crawl on all fours by the force of the gale, he eventually made his way to the end of the low-level girders ([Figure 19](#)). Further progress was impossible: the whole length of the high girders had disappeared into the river taking the train with it. Although steamers went out later that night, no survivors were found.

Figure 19 Representation of the fallen high girders from the last standing pier on the north end of the bridge

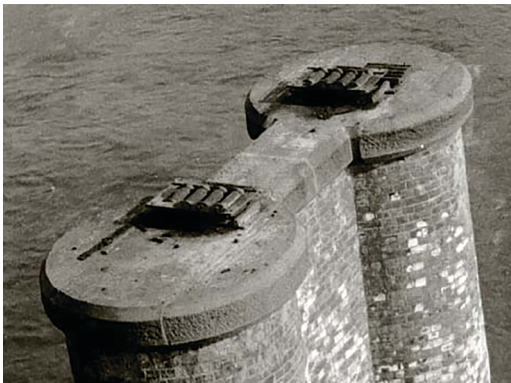
So, what happened at this pier? The girders were supported here only by resting freely on a roller bearing plate, and they were not fixed against lateral movement ([Figure 10](#)). It is known the girders remained substantially intact during and after the fall ([Figure 22](#)), and must have been wrenched sideways from the standing pier. As they were pulled off the pier, they pulled other parts of the structure off, which fell vertically and caused much of the collateral damage seen in [Figure 34](#). This would probably have included the cast-iron rollers and the plate on which they rested on the columns very near the top of the girders ([Figure 37](#)).

The suggestion is reinforced by examination of the north pier, where even more collateral damage has occurred. It had a similar structure with a roller bearing plate, and most of the centre section supports were destroyed. Nevertheless, the damage to the tie bars and struts shows the connections to the columns were the weakest, no matter how that damage was caused. Most have failed by fracture of lugs, the connections cast into the structure of the columns.

Figure 37 Top of one of the brick piers of the old Tay bridge showing the cast-iron roller bearings *in situ* before the pier was demolished

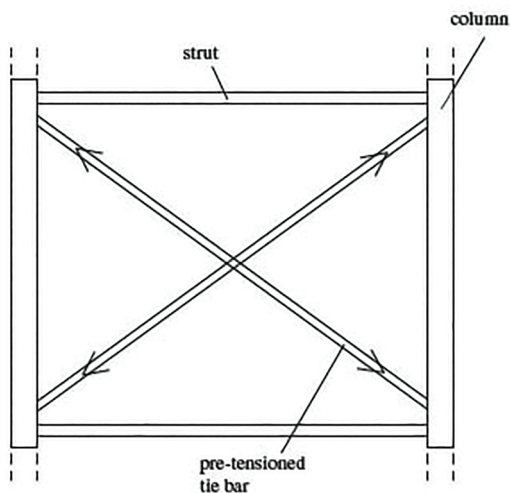
One way to explore further the simple theory is to examine a single cell of the structure, as shown by the diagram in [Figure 40](#). The cell is defined by the two columns on either side and the two horizontal struts, with the pre-tensioned diagonal tie bars running from corner to corner of the cell.

Figure 40 Single cell of the centre part of one of the tiers showing the effect of pre-tension on the diagonal tie bars
